# Impacts of Hurricane Mathew on adjacent developed and undeveloped barrier islands in southeastern North Carolina

Volume 53, June 2022, #102391

**Abstract:** High-magnitude storms such as hurricanes can cause significant and potentially long-lasting morphological coastal change, particularly along low-lying barrier islands. This study investigated the impacts of Hurricane Matthew (2016) on neighboring undeveloped Masonboro Island reserve and engineered/nourished Wrightsville Beach barrier islands, located in southeast North Carolina. Using a combination of high-resolution pre- and post-storm RTK-GPS beach surveys, coupled with direct observations, storm surge calculations and aerial imagery, a range of contrasting storm-induced coastal changes and impact regimes were identified across the two adjacent barriers. Storm impacts were especially pronounced across low-lying undeveloped central/southern Masonboro Island, which was dominated by significant overwash processes, leading to landward directed barrier crest migration. In contrast, only short-lived and minor collision with the base was observed at Wrightsville Beach, where storm impacts were dominated by a swash storm regime

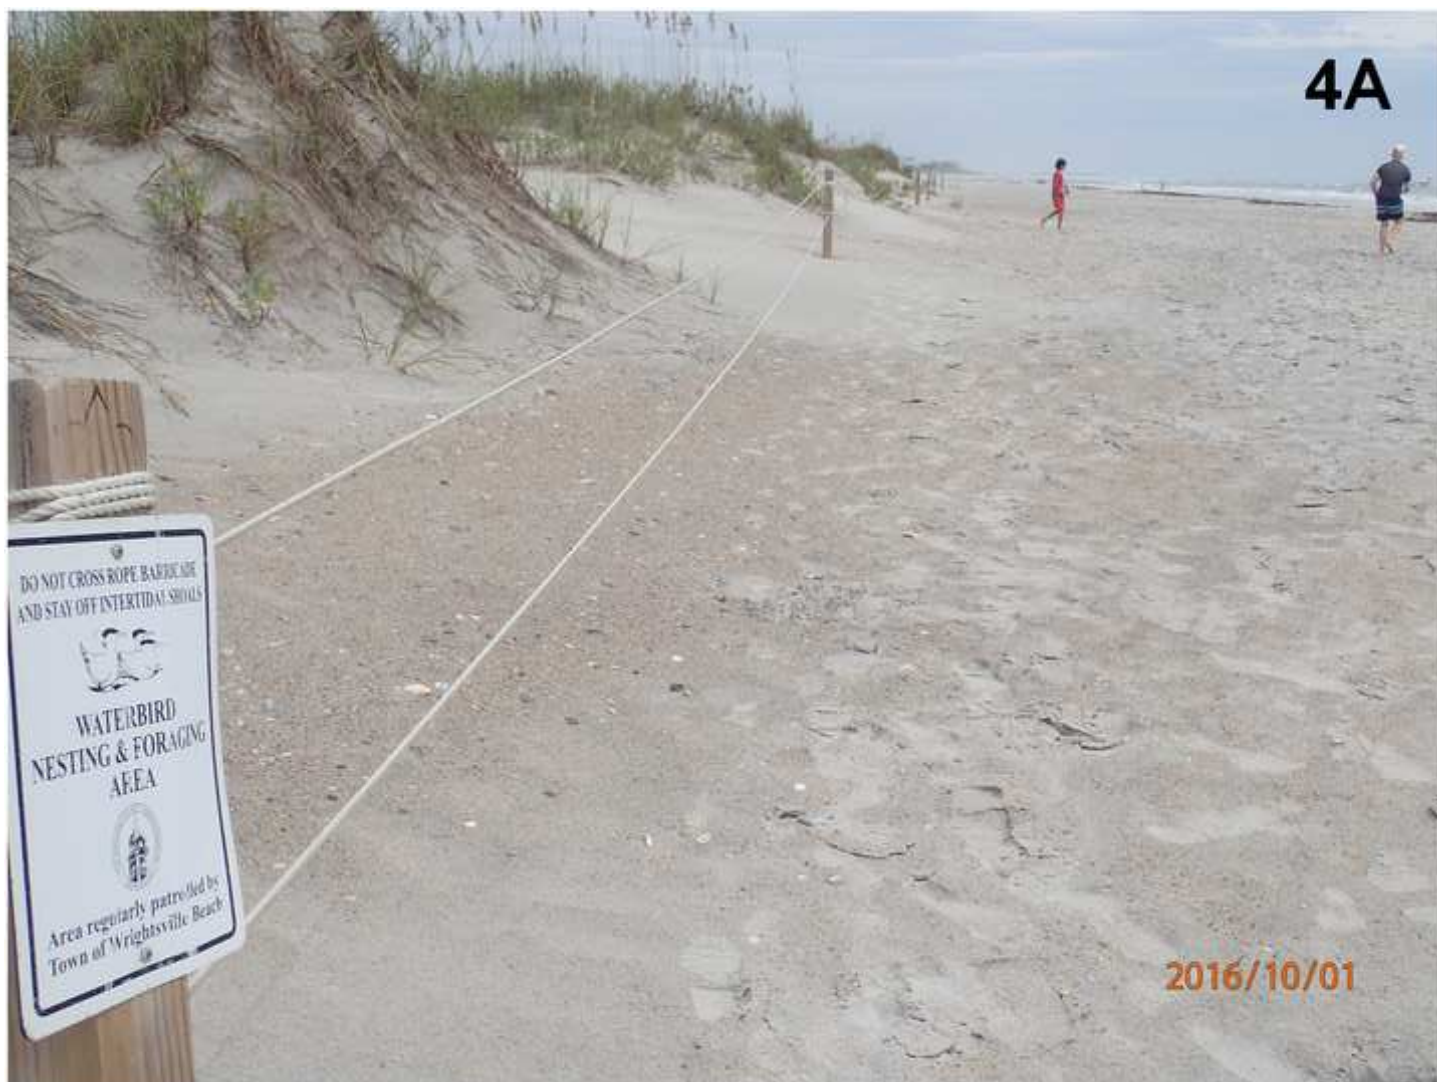
4A

WB01 comprises the old location of Mason Inlet, situated within a defined Inlet Hazard Area. At the time of the pre-storm survey visit, the forebeach was wide and relatively flat, backed by a discontinuous and low elevation frontal dune ridge with moderate to low vegetation cover (Figure 4A). A post-storm site visit on October 13<sup>th</sup> showed that storm-induced surge only reached as far as the base of the frontal dunes, resulting in minor erosion and scarping, coupled with vegetation loss and/or burial from sediment deposition (Figure 4B). There was no evidence of dune breaching, channelization or overwash at the site which is consistent with extreme water levels computed for this profile which indicate that only swash and collision impacts were likely to be observed (Figure 5). Although collision with the dune was computed based on the combination of morphological and hydrodynamic data, i) the prevalence of a short duration collision regime and ii) the maximum extreme water level ( $R_{High}$ ) only exceeded the base of the dune by a few centimeters (Table 1), supports the negligible storm impacts on the dune but consistent erosion of the beach under a swash storm impact regime in WB01.

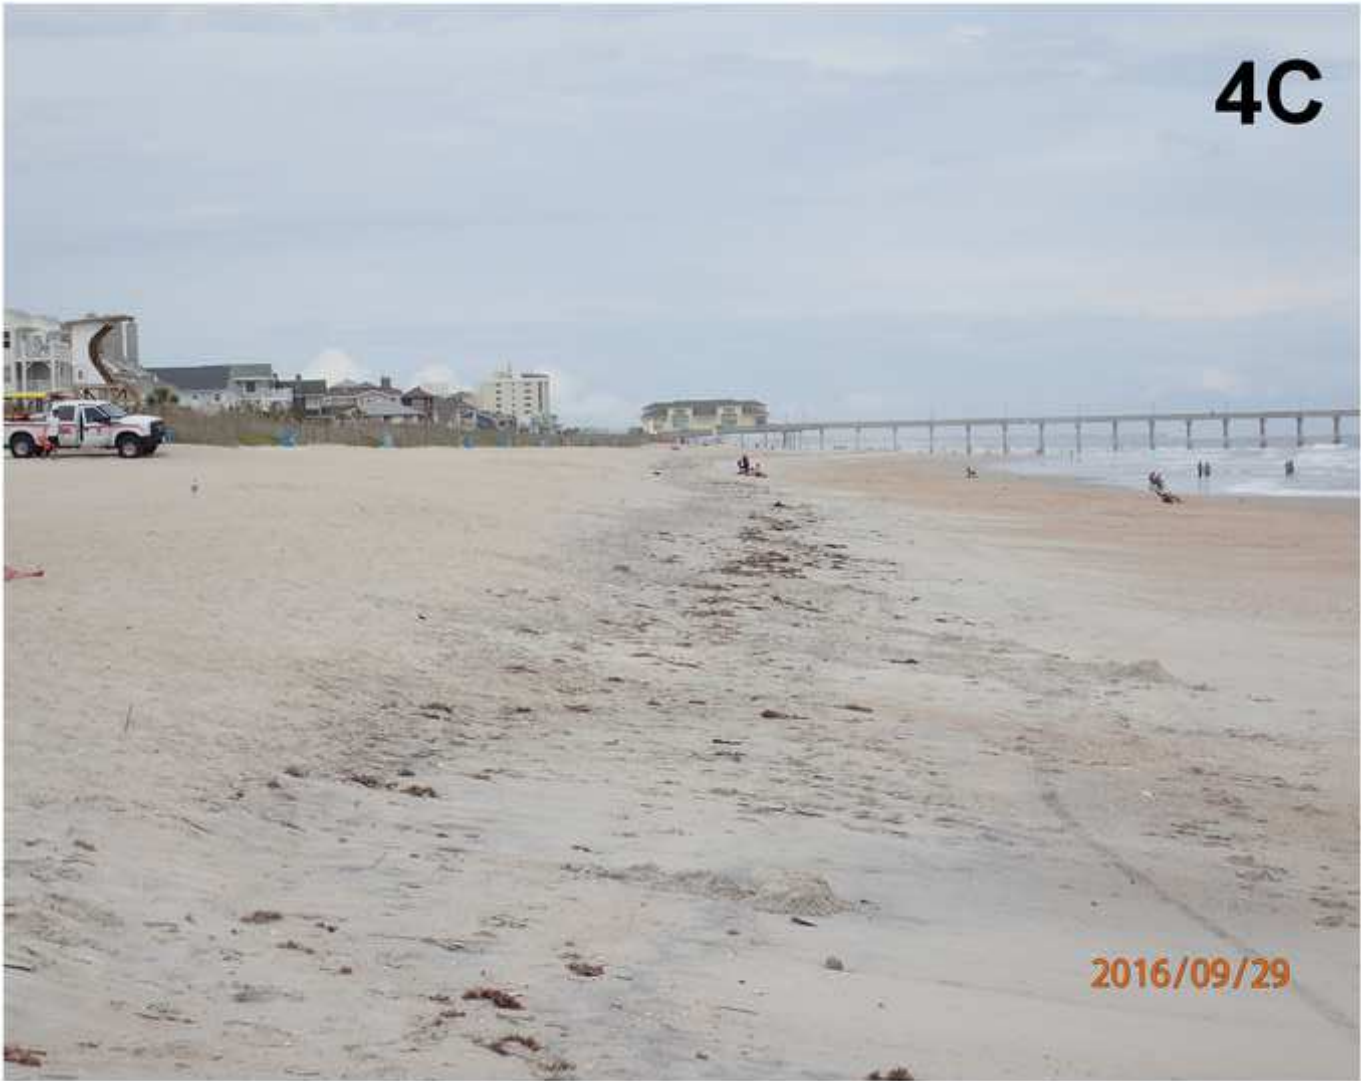
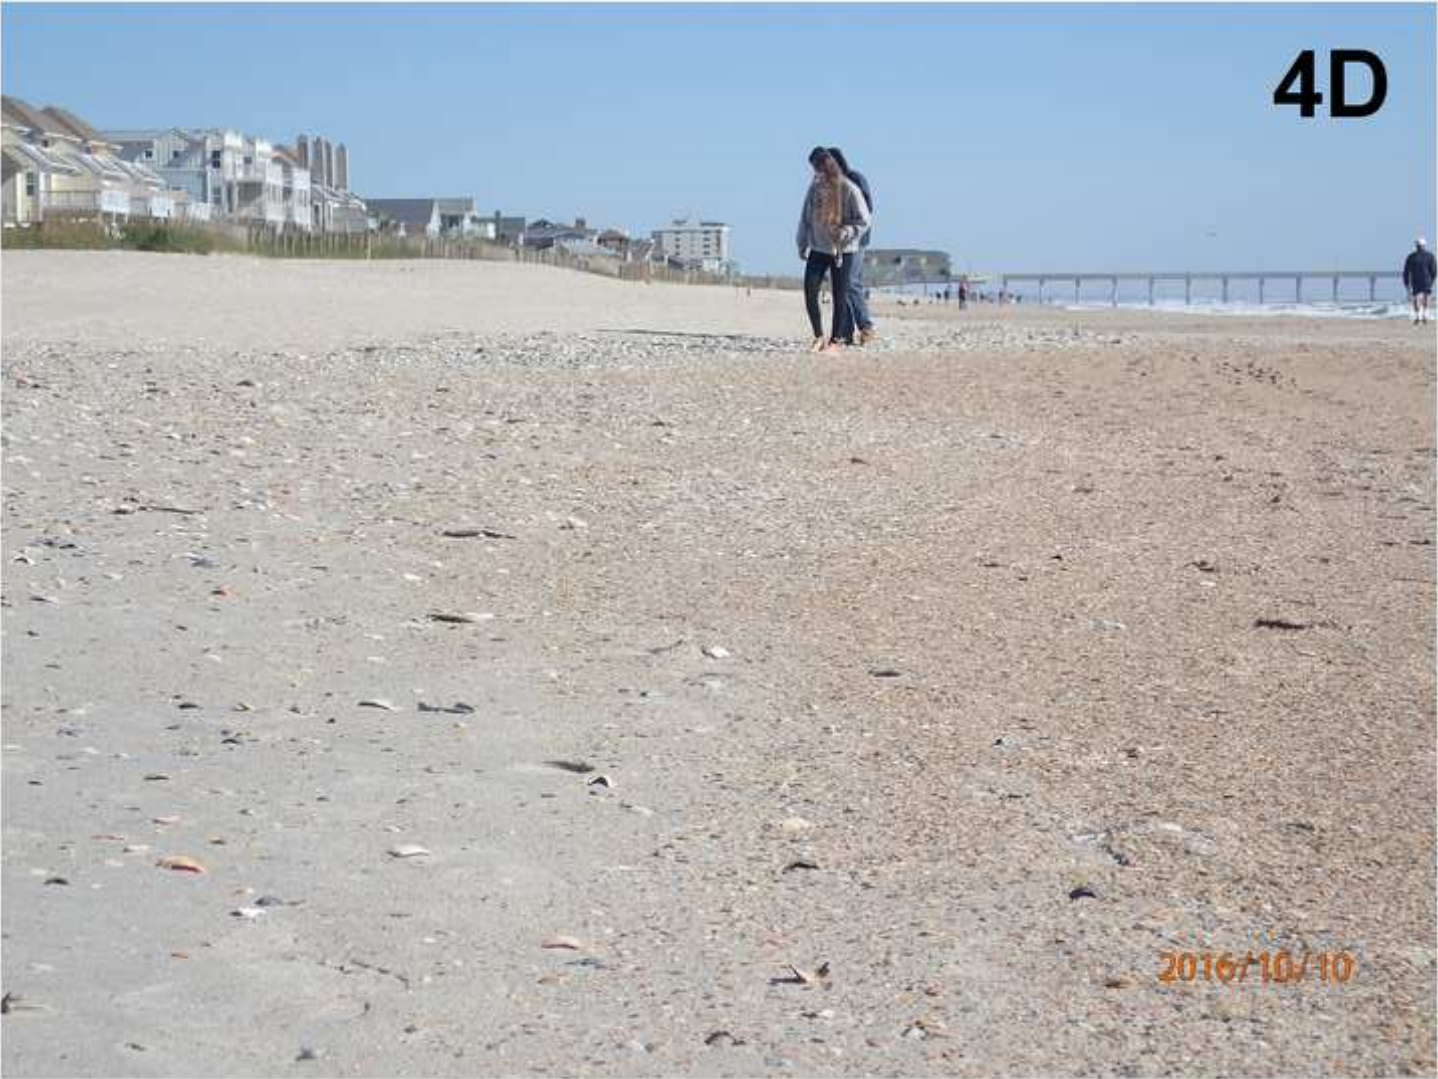
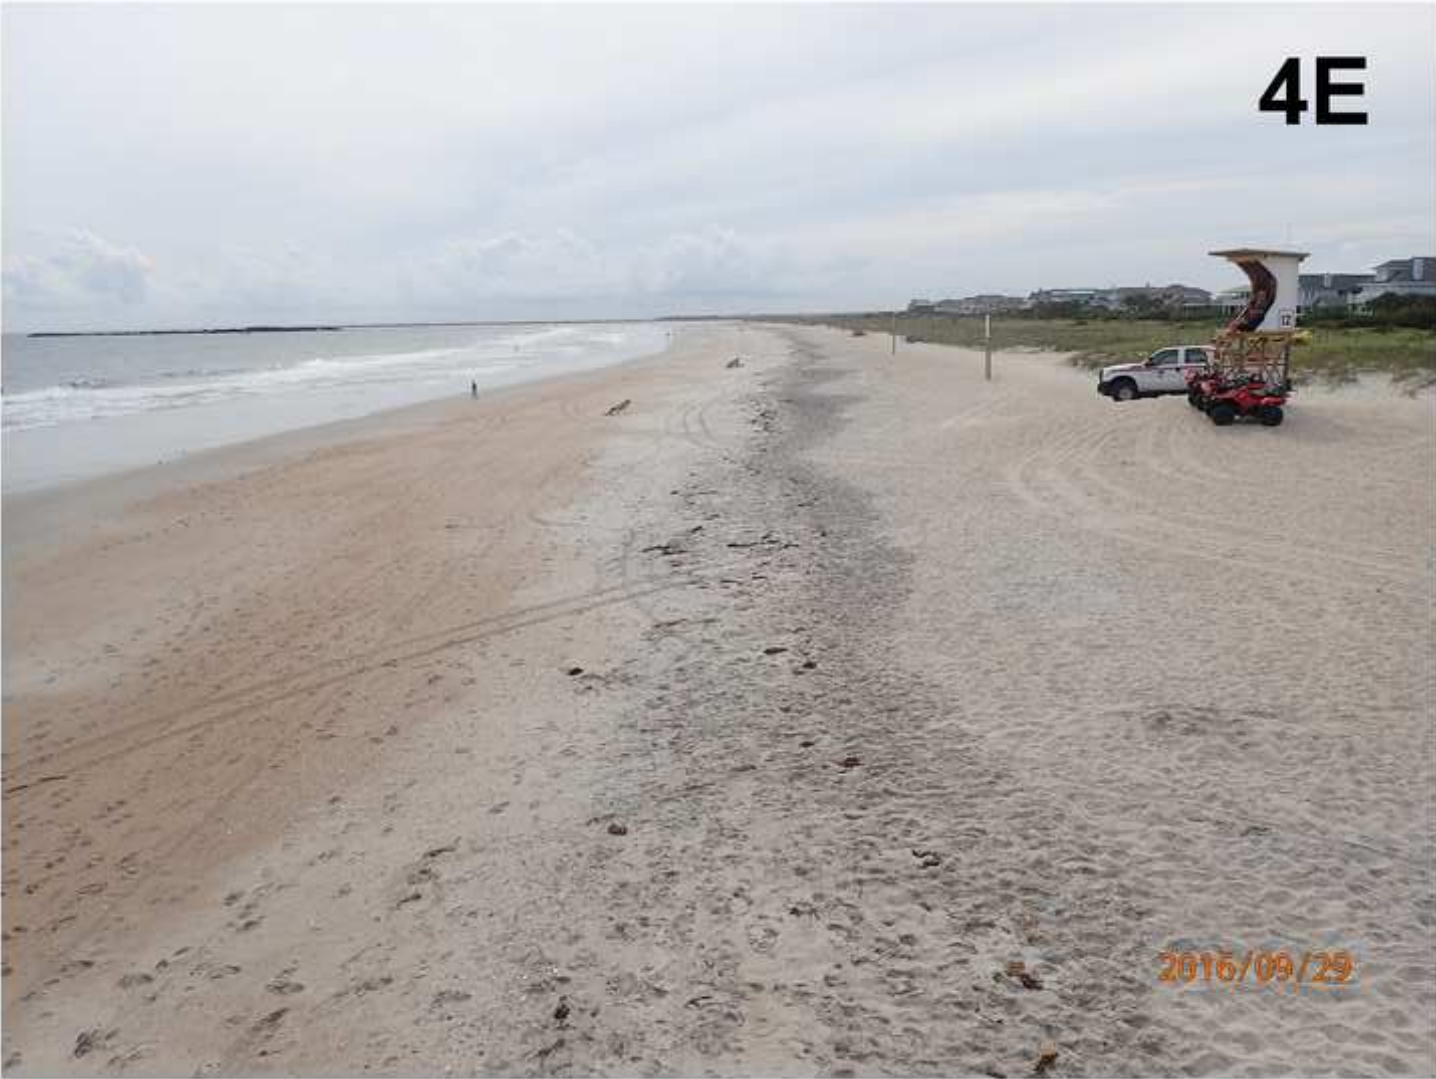
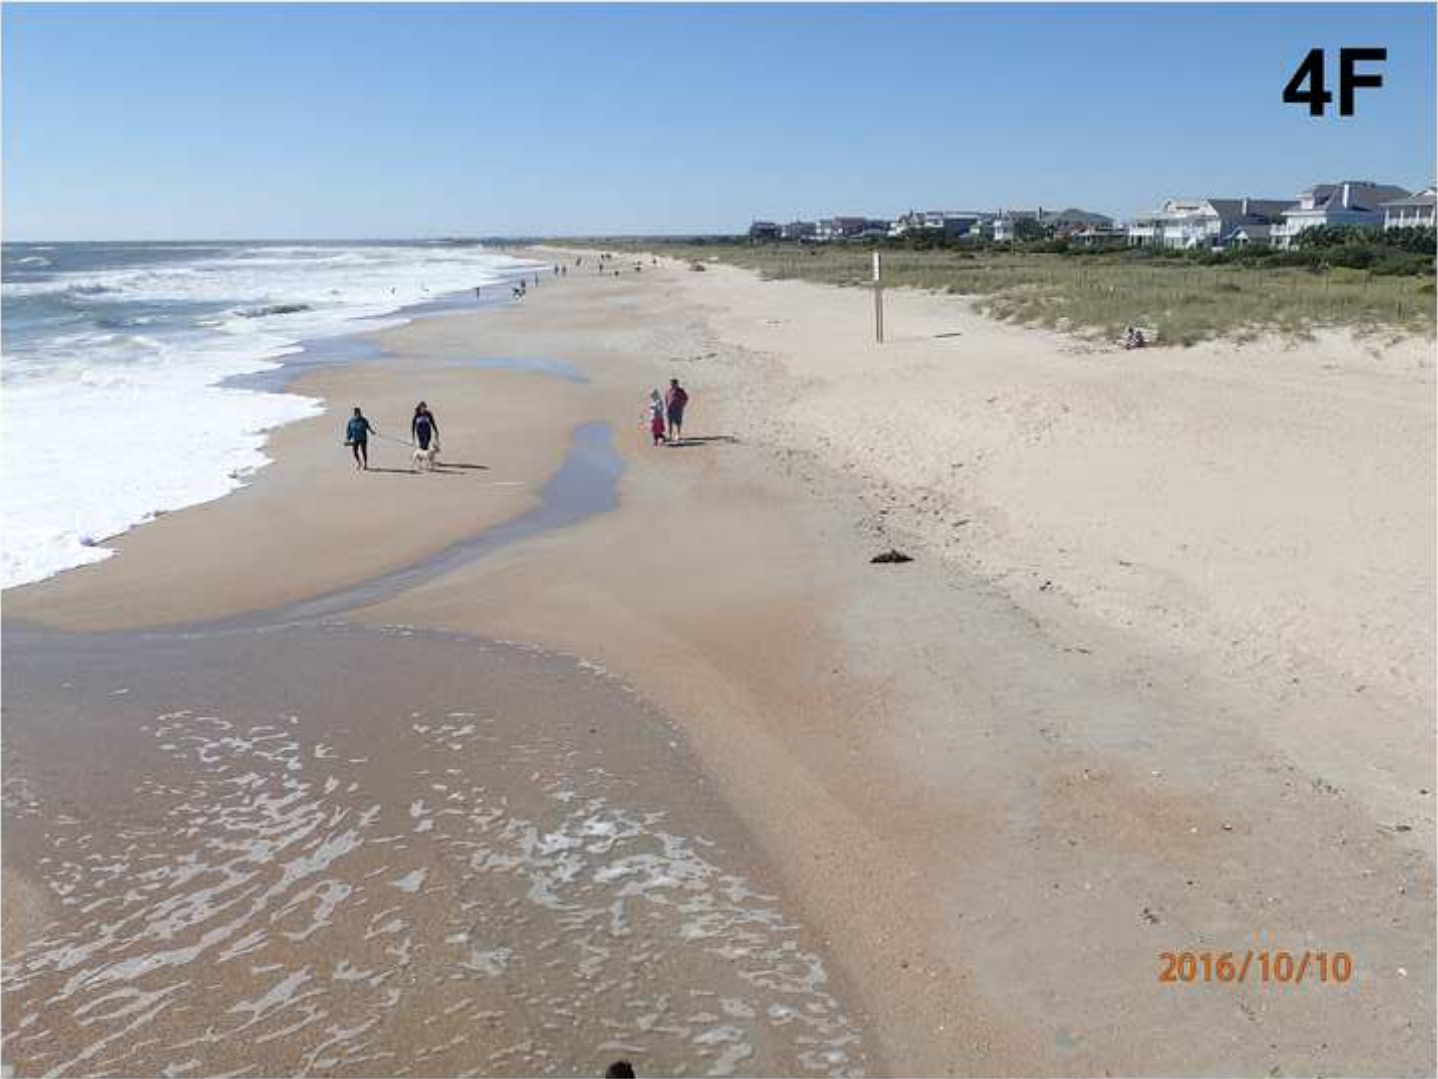
ii) berm removal and profile straightening. These were relatively consistent along the three sections surveyed, as outlined in Figures 4 and 5.

Pre-storm beach profile RTK data showed a near-horizontal to convex profile shape, with a low-relief 30 m wide berm extending from the frontal dunes, and maximum and minimum elevations of 1.77 m and -0.10 m (NAVD 88), respectively (Figure 5). Post-storm RTK profiles showed moderate erosion across most of the beach, with the beach changing from an accretional convex to erosional concave profile shape, attributed to the removal of the pre-storm berm under a swash impact regime. The seaward and landward margins of the beach had minimal post-storm change (Figure 5).

WB02 is located along the central part of the island, where mostly single-family or multi-story homes are located. Pre-storm observations showed a wide, almost horizontal berm that dropped steeply towards the water near the high-tide line (Figure 4C). Post-storm observations revealed a much steeper beach across the length of the profile, in addition to storm-induced deposition of shell gravel onto the beach (Figure 4D). The previously wide, flat berm was eroded. There was no evidence of dune erosion or scarping at the landward margin; instead fine-grained sand was deposited in the backshore region, near the base of the dunes. Similar to WB01, while the computed storm impact parameters indicate minimal occurrence of a collision regime, this was short lived (Table 1). Although extreme water levels exceeded the base of the dune at WB02 (Figure 5), the post-storm beach profile suggests that the impact of the storm at the dune base was accretional rather than erosional. A comparison of pre- and post-storm RTK profiles confirmed significant berm erosion, profile straightening and steepening (Figure 5), which are consistent with the long duration of the swash storm impact regime (Table 1). The maximum storm-induced vertical erosion was close to 1.0 m at the seaward cusp of the berm. The morphological changes observed also support some backshore and intertidal accretion, with the material likely derived from erosion of the pre-existing berm.

scarping. Survey and visual observations are supported by computed storm impact regimes, since only swash regime was estimated for this section of Wrightsville Beach (Table 1). Pre- and post-storm beach profiles comparisons confirmed minimal storm-induced change (Figure 5), especially compared to WB01 and WB02 further north. Maximum vertical erosion was ~60 cm near the central part of the beach, resulting in a slightly more concave-shaped beach after the storm. There was no change along the backshore or dune base, confirming that extreme water levels ( $R_{High}$ ) did not extend as far up the beach. The eroded berm material may have been transported seaward and redistributed along the intertidal area, shown by the 50 cm post-storm deposition at the seaward end (Figure 5).

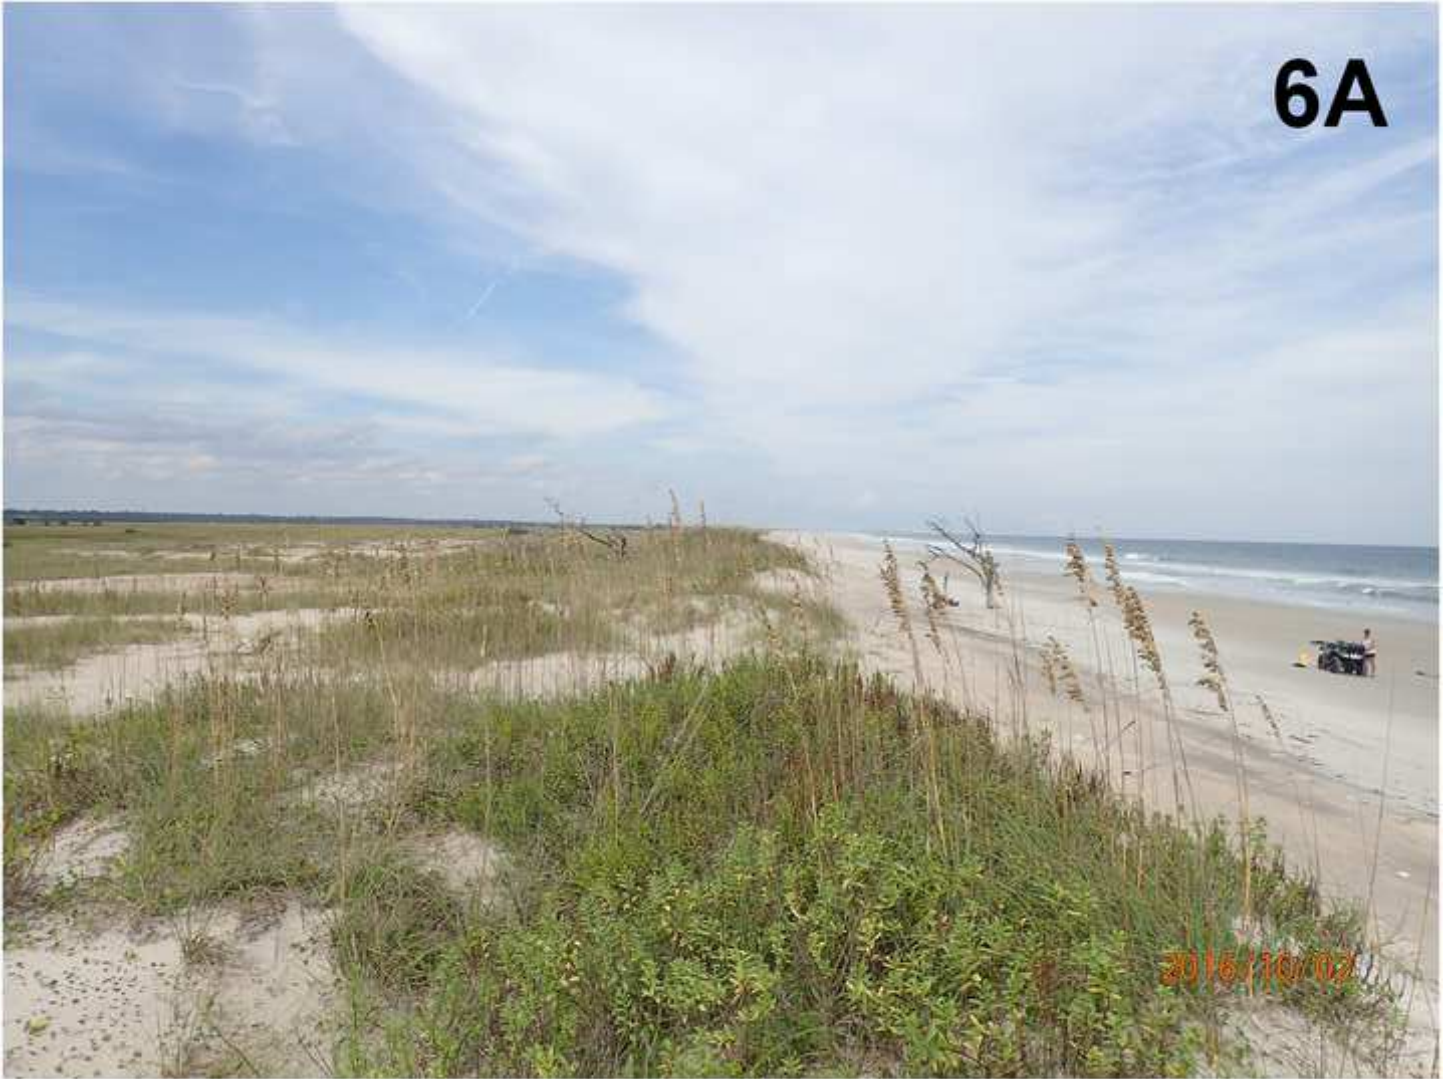
6A

These two locations are analyzed jointly because of their similar geomorphological characteristics and identical storm response. Pre-storm observations revealed a low-elevation, continuous to semi-continuous and moderately vegetated dune system backing the main beach (Figure 6A). There was evidence of previously overwashed sections, comprising narrow, infilled channels with minimal vegetation growth, which often extended across the width of the island (Figure 6B).

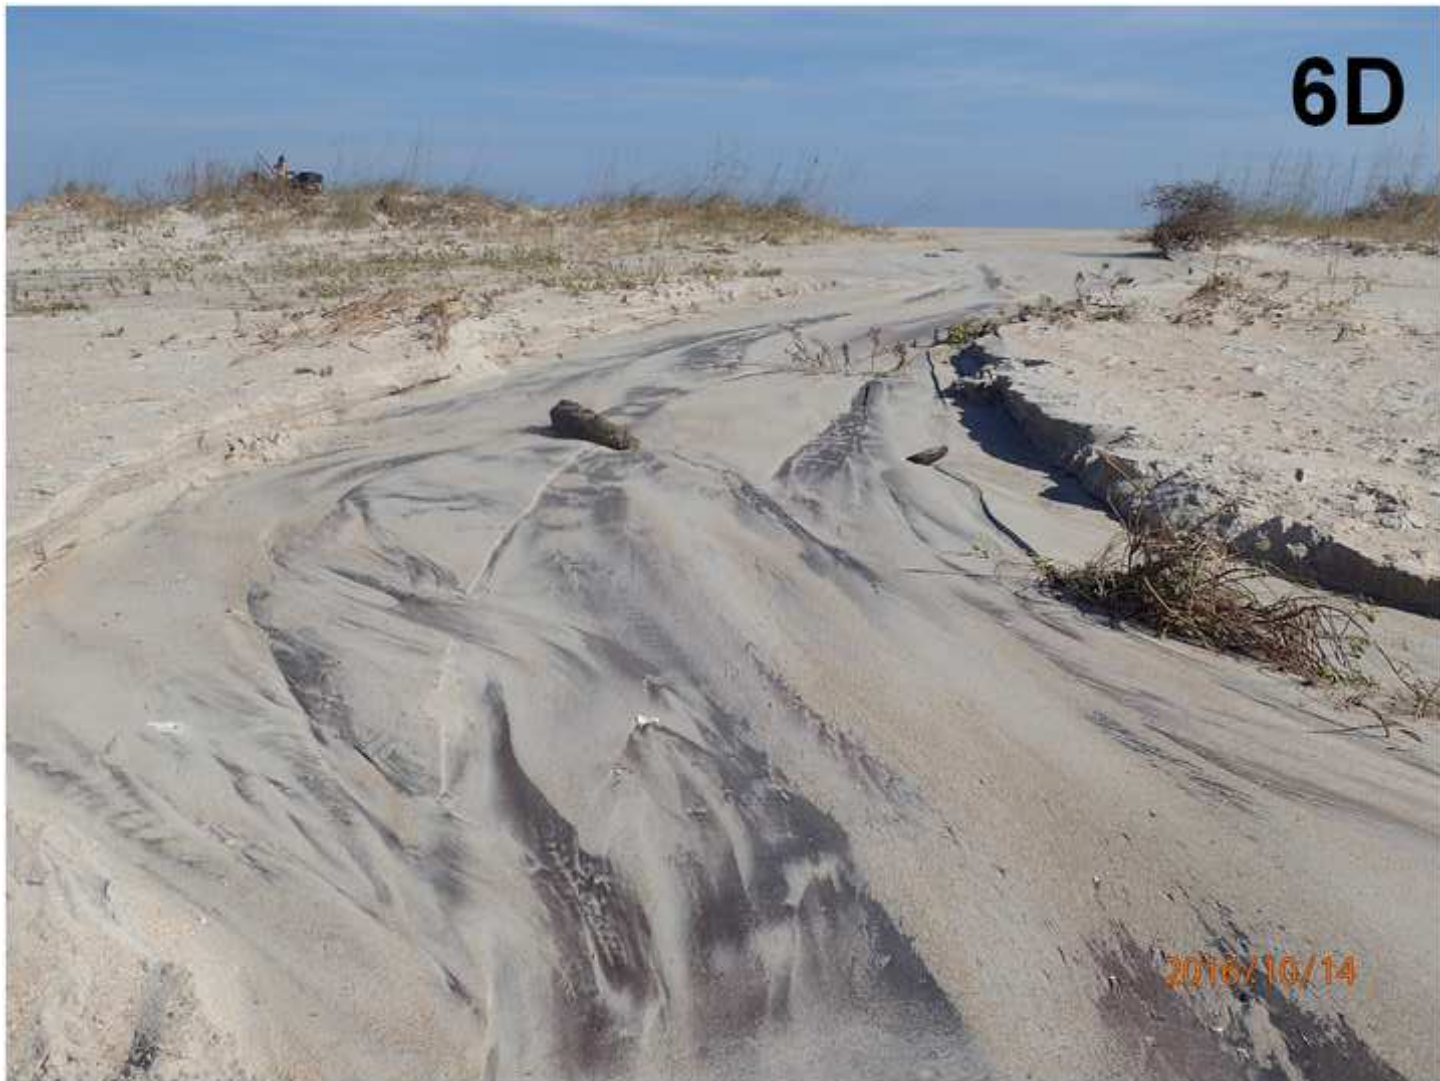
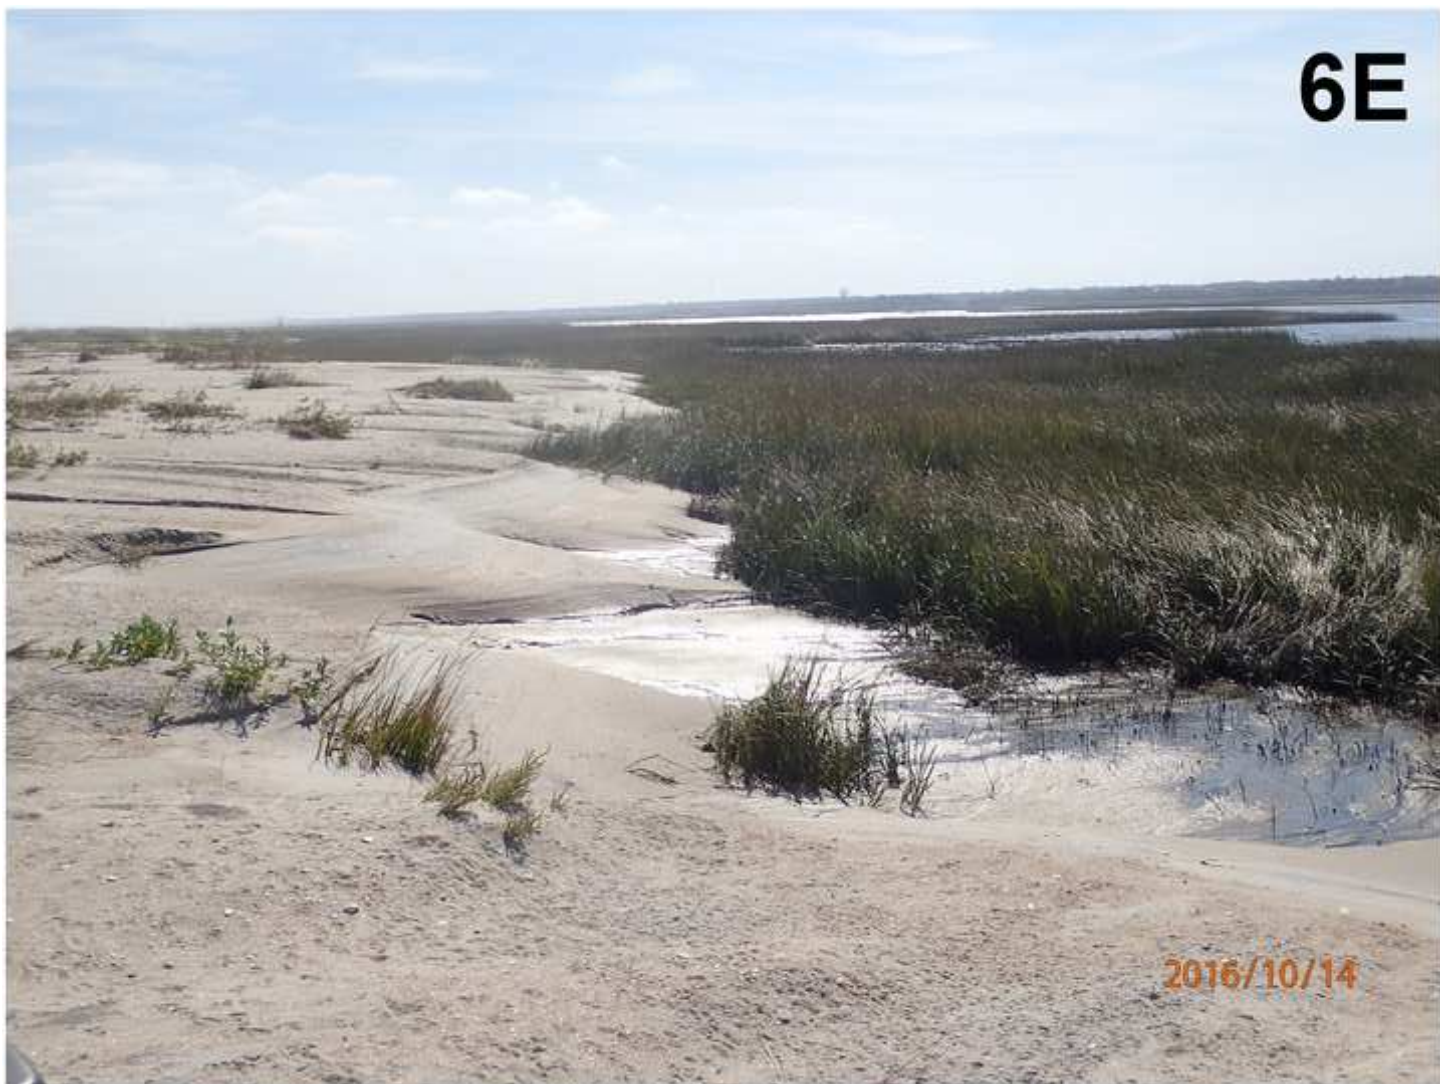
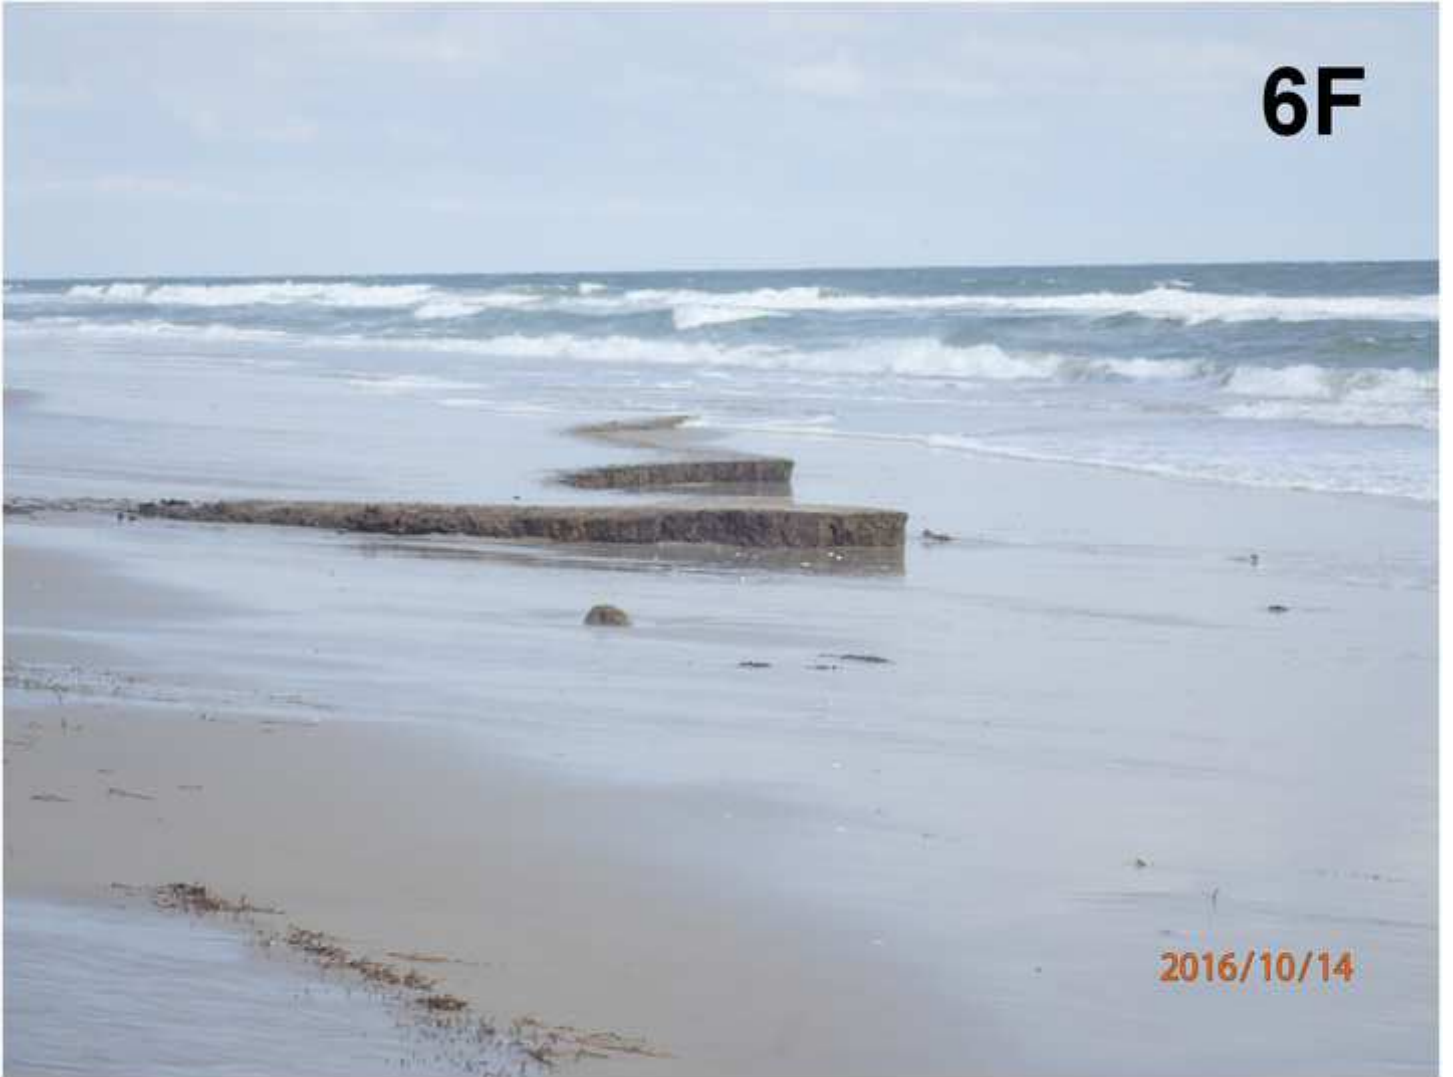
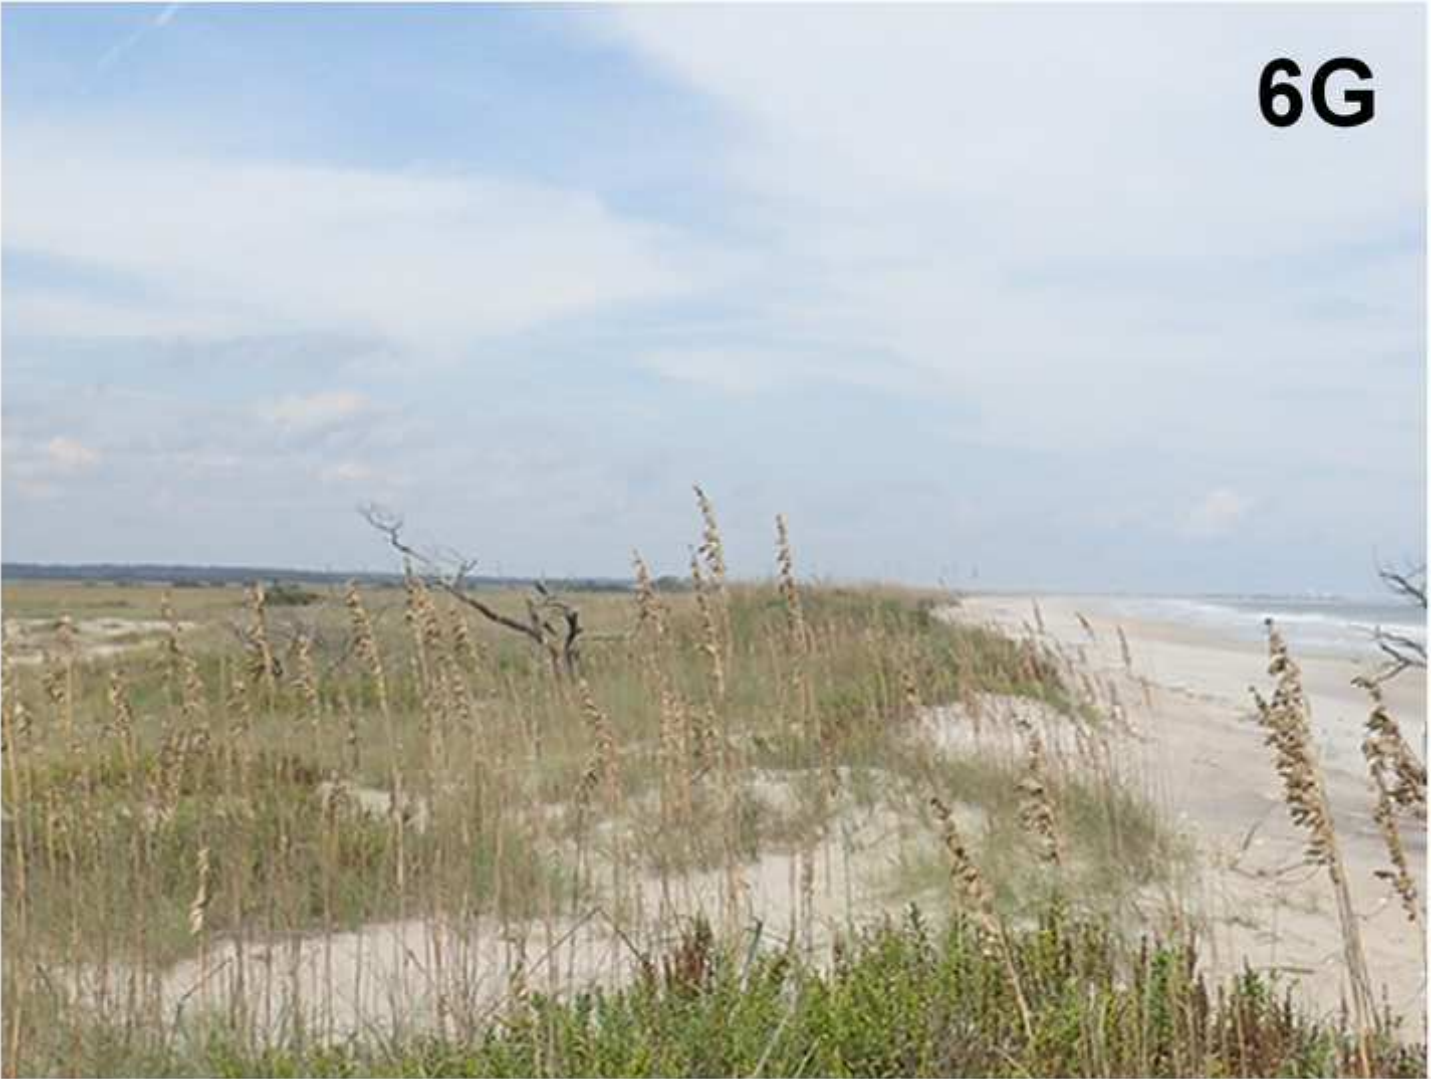
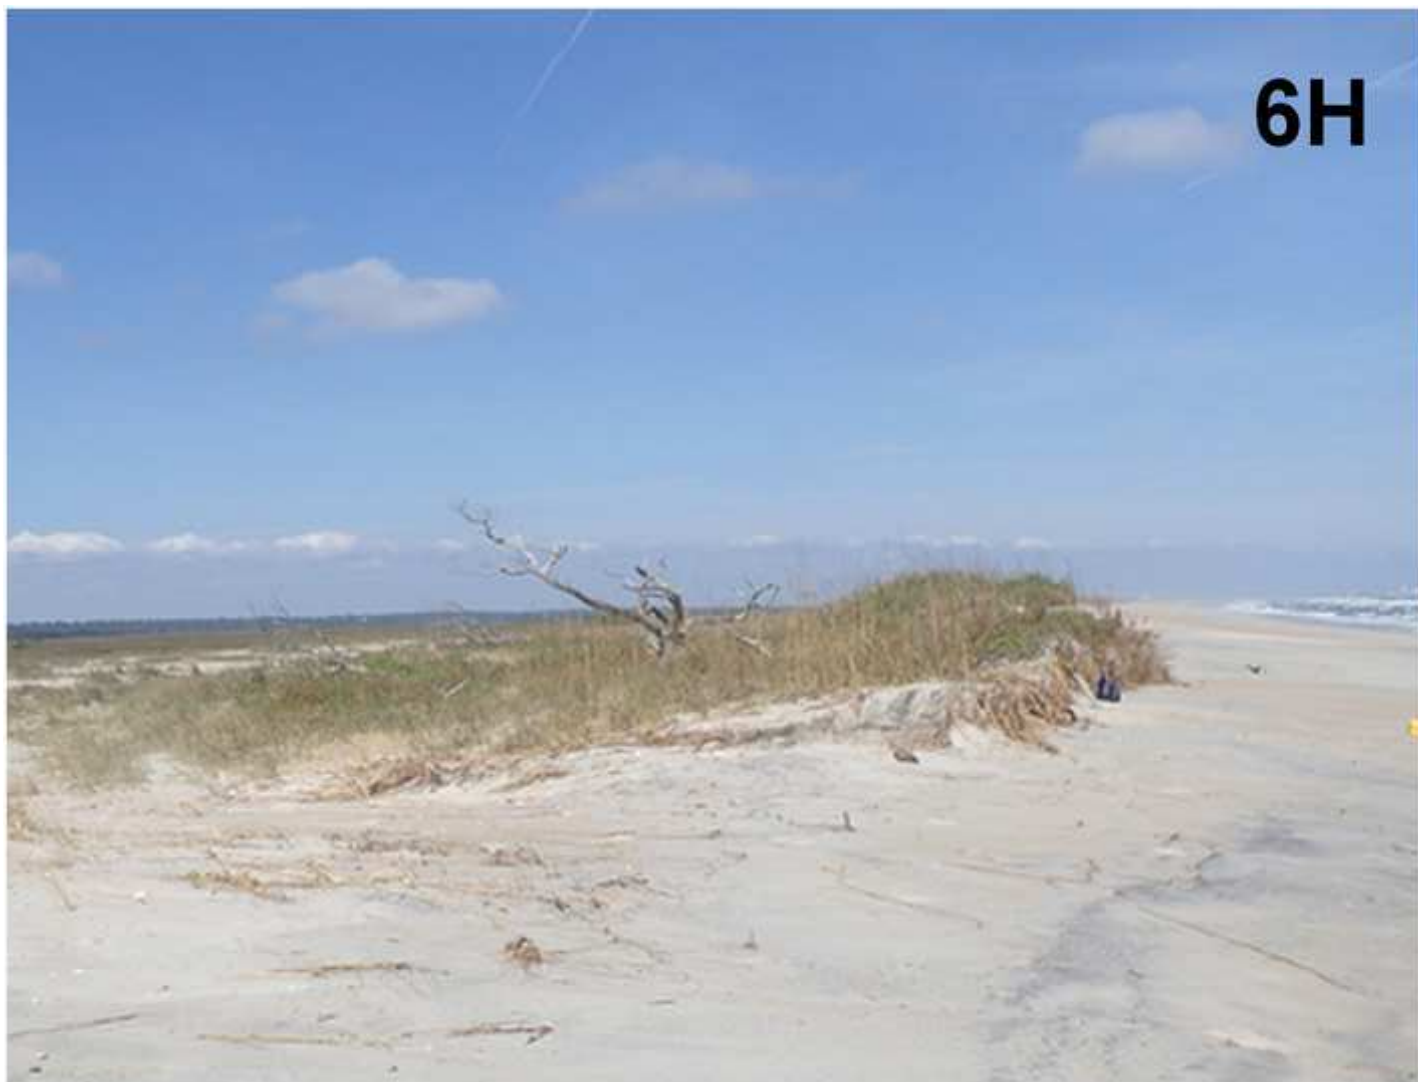
A post-storm site visit, approximately one week after Hurricane Matthew, revealed significant impacts to the beach, dunes and back-barrier areas at both locations. The intertidal beach was significantly narrower and steeper and often overlain with coarse shell hash, shell fragments and whole shells. The majority of the frontal dunes were severely eroded and vegetation cover was either stripped or buried (Figure 6C). Channel breaching was also widespread, especially where previously infilled channels had been identified earlier (Figure 6D). The landward margin of the island had fresh washover fans and terraces which extended into the adjacent marsh (Figure 6E). Coastal impacts were particularly notable near MB02, comprising some of the lowest elevations along Masonboro Island. Other obvious storm impacts included exposure of underlying humate sandstone on the forebeach (Figure 6F), in addition to boulder-sized clasts of peat and *coquina* which were scattered across the island. Pre-storm elevations of the foredunes ranged from approximately 3.4 m to 2.6 m for MB01 and MB02, respectively (Figure 7). The total width of the island at these locations was 90-100 m, with the longer profile corresponding to MB01. The upper beach face and frontal dune was significantly steeper compared to the sub-horizontal back-barrier region behind the main dune system. The landward margins of the beach often dropped steeply into the marshes at the back end of the island (Figure 7).

Post-storm results showed significant, up to 50 cm, erosion of the dune crest (Figure 7), supporting the idea that MB01 and MB02 were subjected to collision and overwash regimes for substantial periods of time (Table 1). While collision dominated, overwash was prevalent during periods of 2:00 to 4:30 hours at MB01 and MB02, respectively. The eroded dune crest sediment was redistributed landward in the form of washover fans and/or sheet deposits (Figure 6C and 6E) though some eroded dune sand may have been deposited on the beach face, seaward of the dunes, due to backwash and/or outwash processes. Post-storm results also showed an overall landward translation of the barrier by approximately 2 to 5 meters, corresponding to the fresh washover terraces on the landward side of the island.

There was evidence of numerous washover deposits and overwash channel incisions across the central/southern part of Masonboro Island. Post-storm observations revealed several temporary breaches, up to 25 m wide and 0.5 m deep, extending across the width of the island. Similar storm-induced washover channel incisions and temporary inlets have been documented at numerous barrier islands across the eastern United States, including for example Masonboro Island (Hosier and Cleary, 1977), Topsail Island, NC (Cleary, 1994); Biscayne Bay (Tedesco et al., 1995), Cape Romain (Sexton and
