The Effect of Discontinuities Characteristics on Coal Mine Stability and Sustainability: A Rock Fall Prediction Approach

Case study: Roof fall accident in Eshkeli coal mine

34th International Conference on Ground Control in Mining

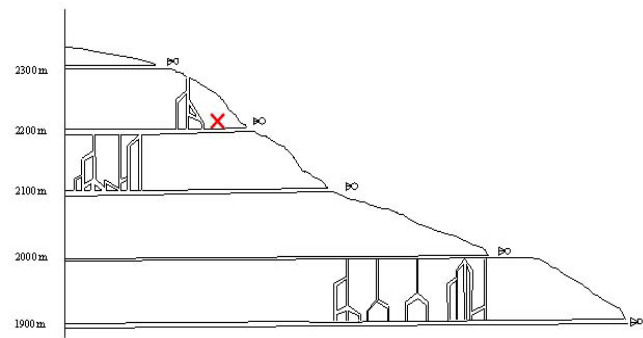
Figure 1. Sketch of Eshkeli coal mine (×: accident place).

Eshkeli coal mine is located in Iran (Figure 1). The geological formation of the mine belongs to the middle Jurassic period. The lithology of the formation includes sandstone, siltstone, mudstone, and coal. The proven reserve has been estimated at 3 million tons of coal. The mine's region has been tectonized by tectonic processes and 11 main faults have been identified, and the average thickness and dip of the coal bed are 3 m and 35° respectively in the mine. The mine has 4 levels from 2,300 m to 1,900 m.

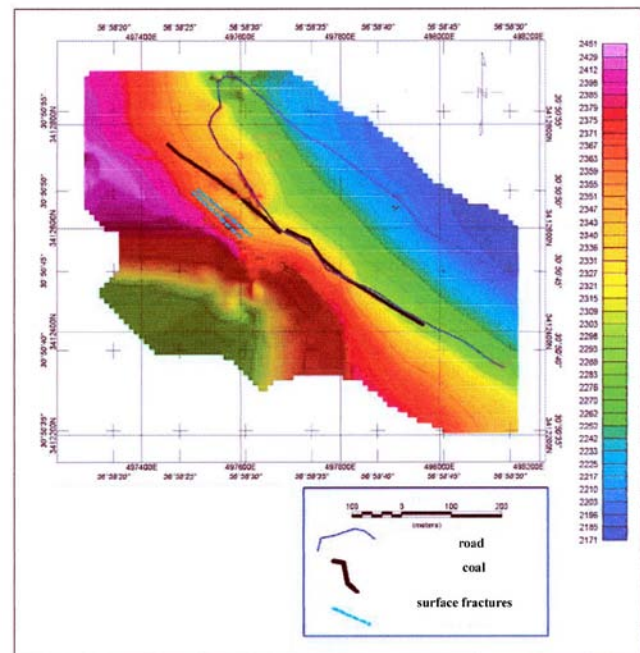
Figure 2. Topography map of the mine region.

The region's topography is rough and many hills and valleys are in the region, as shown in Figure 2.

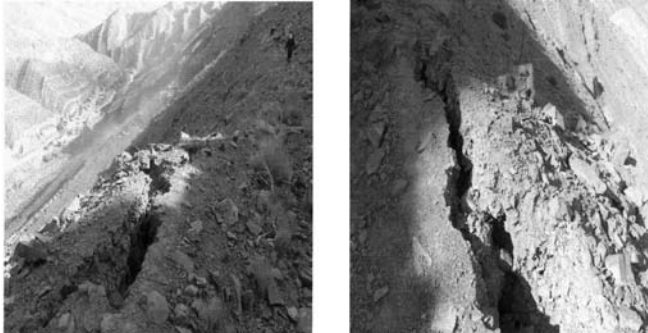
Figure 3. The cracks that were displayed on surface of failure zone.

were retrieved four months later after drilling a rescue tunnel. The failure was so severe that it caused some cracks on the earth (Figure 3). A sketch of the collapsed stope (stope 103) (level 1 of the mine) is shown in Figure 4.

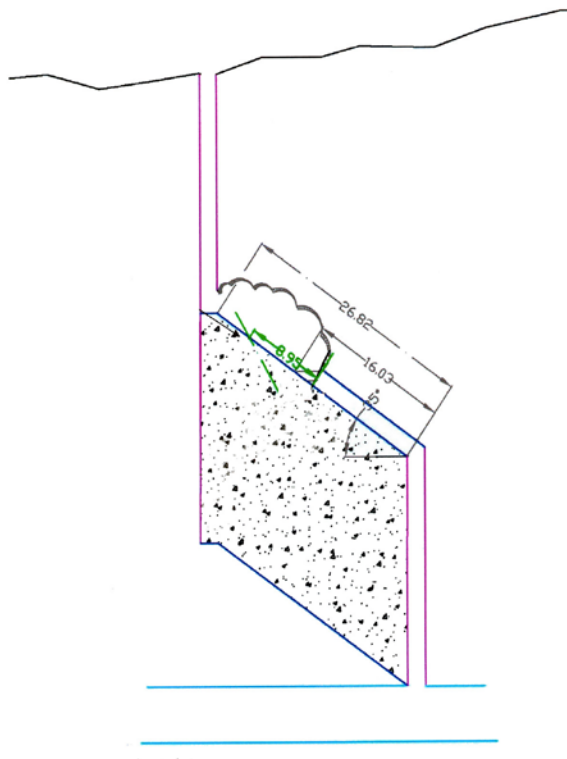
Figure 4. The collapsed stope (stope 103).

The green lines show the collapsed part of the stope, and 8.95 m of stope length (26.82 m) was covered by the debris of the failure. The yielding steel sets that supported the haulage tunnel that was on level 2200 m (see Figure 1) were affected by the failure and they were compacted as much as 30 cm, and the struts were also deformed relatively (Figure 5).

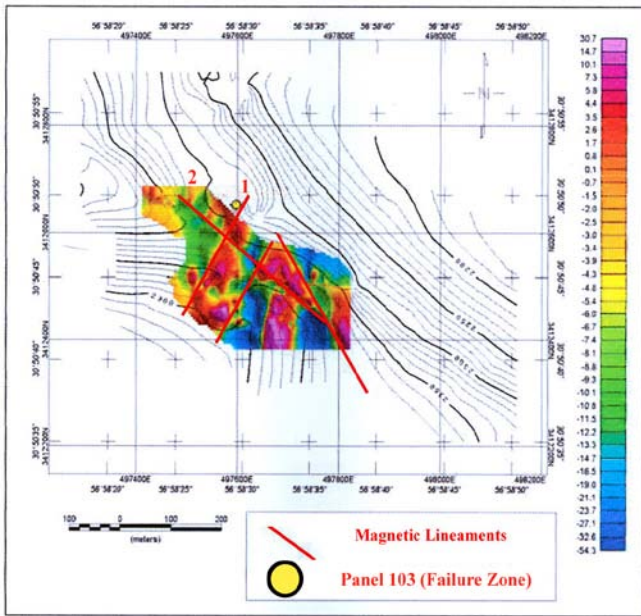
Figure 6. Magnetic horizontal profile.

Magnetic lineaments were found by magnetic method and are shown in Figure 6, which depicts geophysics' horizontal profile. The two main separate faults that affected the failure zone are shown as 1, 2 discontinuities in Figure 6, where the location of the collapsed stope is shown by the yellow circle. The third discontinuity was not uncovered by the magnetic method, so the resistivity method was applied as the additional measurement.

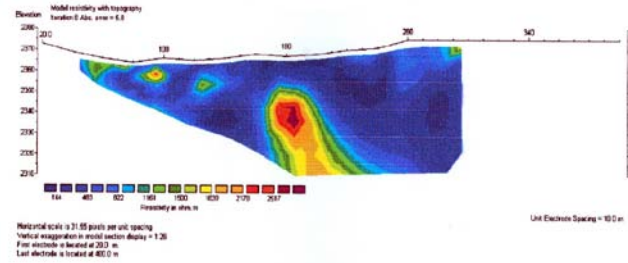
Figure 7. Electrical resistivity vertical profile.

The vertical profile of the failure zone is shown in Figure 7. Failure zone started from the level of 2355 m (Figure 7), and the height between top and bottom of the failure zone is estimated as 20 m (from 2375 to 2355) and extended to the level of 2200 m, where there was the coal bed. Thus, this coal bed acted as a weakness plane or discontinuity.

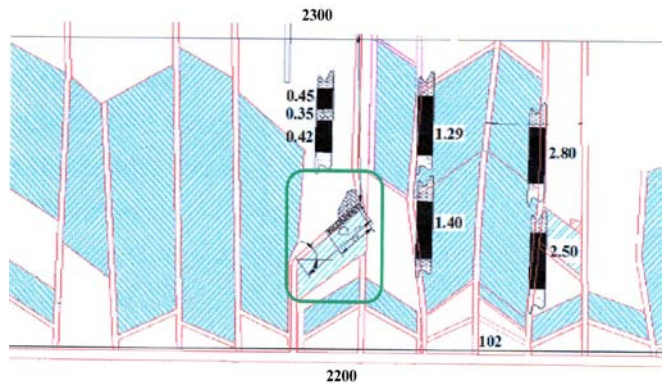
Figure 8. The section of changes in thickness of coal bed.

Bed separation and failure can occur along the bedding planes in stratified deposits, especially when the thickness of the coal seam is not uniform. It is, therefore, possible that coal bed released from the hanging wall. In the present case study, the thickness of the coal bed fluctuated vastly between the level of 2300 m and 2200 m in the mine. The changes in thickness are shown in Figure 8 (from 2.80 to 1.29 to 0.45 or 2.50 to 1.40 to 0.42 m) [9].

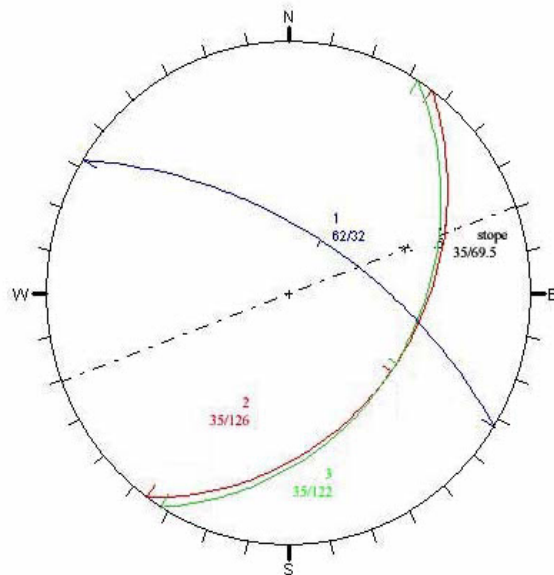
Figure 9. Stereographic projection of the discontinuities orientations and stope axis.

A full screen stereographic projection of the discontinuities orientations and stope axis are shown on the stereonet Figure 9.

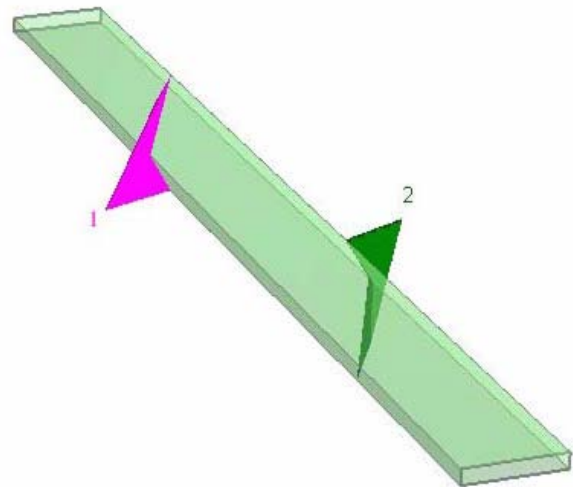
Figure 10. Perspective view of the stope and its wedges.

Workers are directly exposed to potentially unstable ground in the stope in traditional underground mining methods such as stull stoping. The stability design must be strict and as perfect as possible as a safety issue in artisanal small-scale mines. Determine the maximum sized wedges that can be formed in roof and sidewalls of the stope 103 by the given discontinuities are shown in Figure 10.

Two perimeter wedges are made by discontinuities, wedge #1 (upper left wedge) and wedge #2 (lower right wedge). In this case, wedge #1 has been scaled by the discontinuity 3 (bedding plane), and its volume and shear force are estimated 267 m³ and 230 tones respectively while wedge #2 is stable completely. The occupational accident in stope 103 is a result of falling wedge #1.

Coal is often well bedded and, as such, the intensity of layering in coal may be much greater than that of any of the other discontinuities. Thus, with regard to excavation stability, layering and control of this structure may require additional ground support and must be conducted very carefully.
