Original article

# Science, value and material decay in the conservation of historic environments

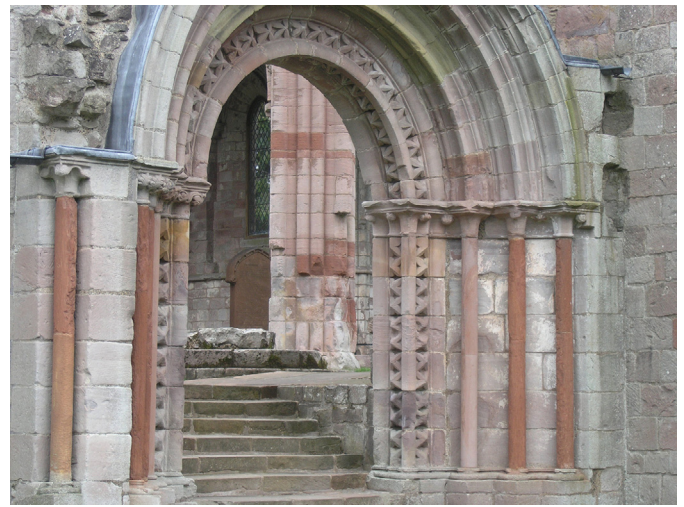
**Fig. 1.** Early Gothic (12–13th C) rounded arch doorway at the remains of Dryburgh Abbey, Scottish Borders. This doorway is the south entrance to the Choir, adjacent to the South Transept of the main church, and the Chapter House. The complex is composed of local white sandstone; the door is surrounded with side pillars of dark red sandstone (Photograph: Maureen Young, Historic Environment Scotland).

Dryburgh Abbey (Fig. 1) was founded in the 1150s by the Premonstratensians on a bend in the River Tweed, approximately 60 km south west of Edinburgh. It is a typical mediaeval, European religious complex, built in the gothic style using locally sourced sandstone. Its walls are >1 m thick, composed of coursed ashlar on the exteriors, and filled with lime and rubble. Internal surfaces would typically have been lime plastered, but most of this is lost now. Its post-Reformation biography was strongly influenced by David Erskine, founder of the Society of Antiquaries of Scotland, who curated it in the image of a romantic ruin in the late eighteenth century. It is a scheduled ancient monument in the care of Historic Scotland (HS) and it is open to the public throughout the year.

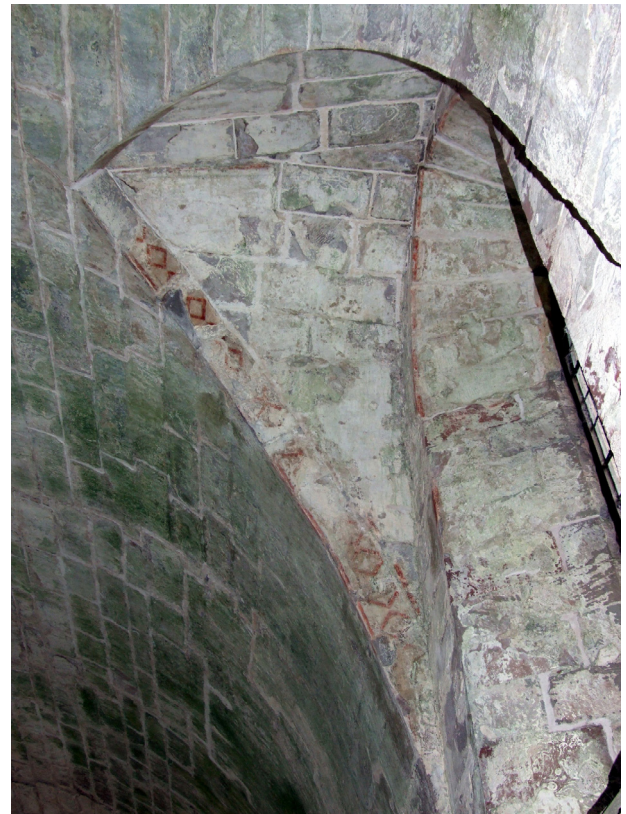
**Fig. 2.** Part of the mediaeval painted ceiling in the Chapter House at Dryburgh Abbey, Scottish Borders, showing details around the east-facing window. The surviving decoration is very faint. The image also clearly illustrates the greening of the stonework caused by the biological colonisation, that is the subject of periodic cleaning. The debate about the control of this surface alteration, through direct environmental control measures or cleaning, is a key conservation issue at the site (Photograph: Maureen Young, Historic Environment Scotland).

because it contains the largest area of mediaeval polychromatic wall decoration in Scotland, painted with tempera onto lime plaster (Fig. 2). However, it has been at risk for some time from water ingress from above and high air humidity. Interventions

to date have included re-roofing and waterproofing, as well as the construction of a French drain to ameliorate rising damp. The decorations and the internal walls suffer nonetheless from colonisation by algae and lichens. The ceiling and walls are currently cleaned using a weak chemical biocidal treatment. This intervention is regarded by HS as an acceptable temporary measure to control the biocolonisation, which returns requiring biannual re-application. Other interventions, such as UV irradiation of the walls, have proven to be ineffective [30].

More recent scientific research and intervention has focused on preventative conservation. Data loggers have been used to monitor the RH (>90%) and the movement of condensing air. Based on these data, the introduction of a door and window glazing has been proposed, allowing active control of humidity to discourage biological growths. To explore the possible effects of environmental modification, HS conducted an experimental trial during 2012–13 in a small room adjoining the Chapter House. The trial demonstrated that relative humidity (RH) could successfully be controlled through this method, but painting conservators, architects and site staff have expressed concerns regarding the wider impact of the intervention. These range from the potential risk of promoting salt efflorescence on the plaster itself, to compromising the atmosphere and authenticity of the Chapter House and the Abbey. At the time of our research, HS was still considering the best course of action.

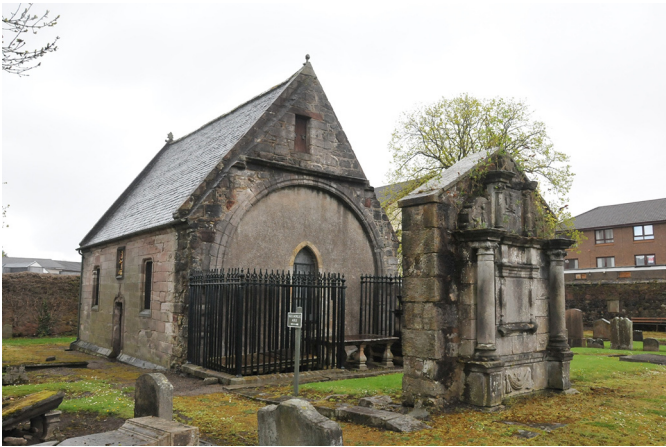
**Fig. 3.** Skelmorlie Aisle, Largs, East Ayrshire (1636–38), is the remaining fragment of a larger, now demolished, church. It now sits in a graveyard in the centre of Largs, enclosed by the surrounding wall and other buildings. Its highlight lies inside, the dramatically carved 17th C loft and mausoleum of the Montgomerie Family (Photograph: Maureen Young, Historic Environment Scotland).

Skelmorlie Aisle (Fig. 3) in Largs, North Ayrshire, was built in the 1630s by Sir Robert Montgomerie of Skelmorlie to provide a place for private worship and burial. Originally the north transept of Largs old church, it remained as a free-standing mausoleum structure in the historic graveyard after the rest of the church was demolished in 1802. The loft of the Montgomerie tomb within the Aisle comprises a richly carved renaissance style canopy, in dense pale gold sandstone, which is raised over a partially sunk burial vault and approached by steps with a balustraded parapet (Fig. 4). The Aisle itself has a wooden barrel-vaulted ceiling, painted with quotes from the Geneva Bible and rich allegorical landscapes by James Stalker, dating from 1638 ([31]: Fig. 5). Together the carved stone tomb canopy and the painted wooden ceiling represent perhaps the most outstanding examples of such work in Scotland. The Aisle is both a scheduled ancient monument and a Historic Scotland (HS) Property in Care. Nevertheless, visitor numbers are considerably lower than Dryburgh, in part because access is more restricted. Keys for the graveyard and the Aisle must be obtained from Largs Museum (open 2–5pm between May and September).

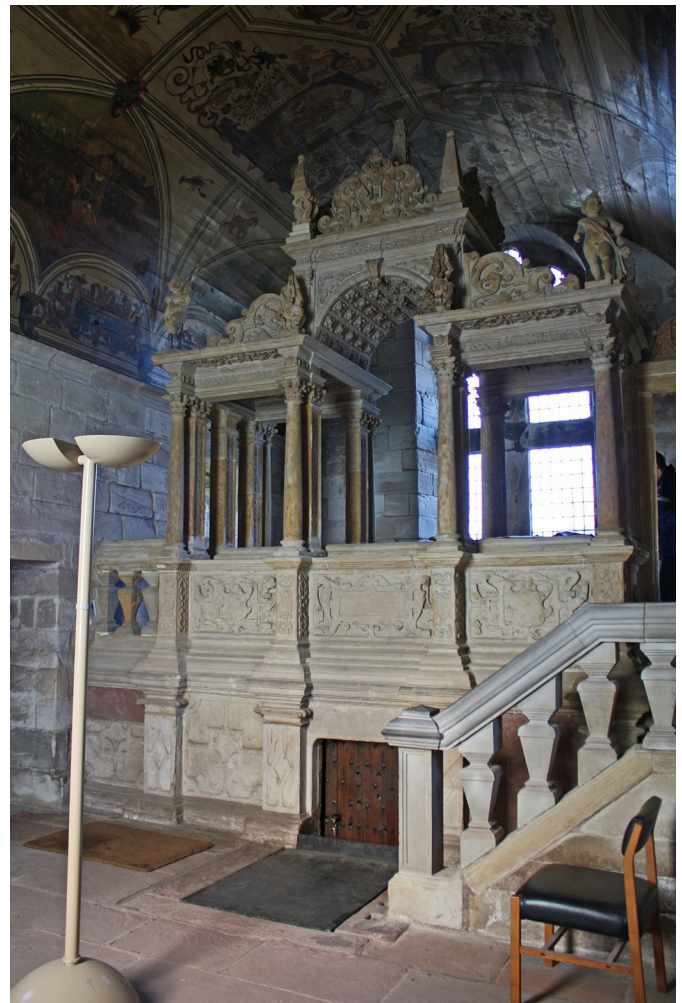
**Fig. 4.** The interior of the Skelmorlie Aisle. The richly carved renaissance canopy sits above the subterranean burial vault of the Montgomerie. The canopy, or loft was the private worship space of the Montgomerie. The wooden ceiling above the loft is richly illustrated (1638) with allegorical classical, biblical and landscape scenes, including one of Largs with the full church with the Aisle itself, before demolition (Photograph: Maureen Young, Historic Environment Scotland).

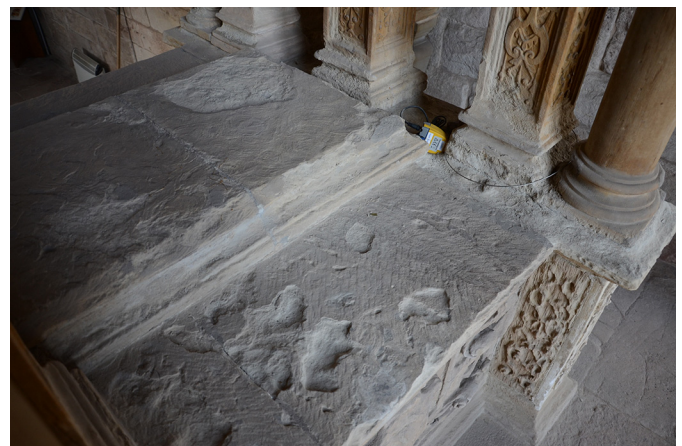
**Fig. 5.** Decay on the top of the tomb at the Skelmorlie Aisle, Largs. Here the dense fine-grained sandstone is suffering from cratering and powdering. At the centre top right of the image, an environmental logging device can be seen attached to the structure, recording conditions of Temperature and Relative Humidity near to where the damage is occurring (Photograph: Maureen Young, Historic Environment Scotland).

The ceiling paintings are in a good state of preservation. The tomb canopy is faring less well. Although the upper stonework is crisp, the lower parts appear badly decayed. Granular disintegration and exfoliation (Fig. 5) have been evident since the mid 20th century, manifesting as craters, flaking and powdering on the surface. Indeed, records show that in 1940 powdered surfaces were treated with Magnesium Fluorosilicate with little evident success. In places, a thin crust has formed, with disintegration continuing beneath. So far, the decay has been attributed to high moisture levels and possible salt contamination. There are also damp patches and salt efflorescence on the walls of the Aisle, which are constructed from course ashlar. The south wall is a particular concern, because it originally consisted of an internal wall with a pointed arch that was blocked and rendered ('harled' in Scotland) externally after the rest of the church was demolished.

The root cause of the stone decay on the surface of the tomb structure remains a puzzle. The isolated character of the decay, and the manner in which it eludes a clear diagnosis, places conservators in long-term dialogue with material scientists, geologists and preventive conservators. Efforts to find out what has been causing the flaking of the stone demonstrate how different professionals engage with material transformation in different ways.

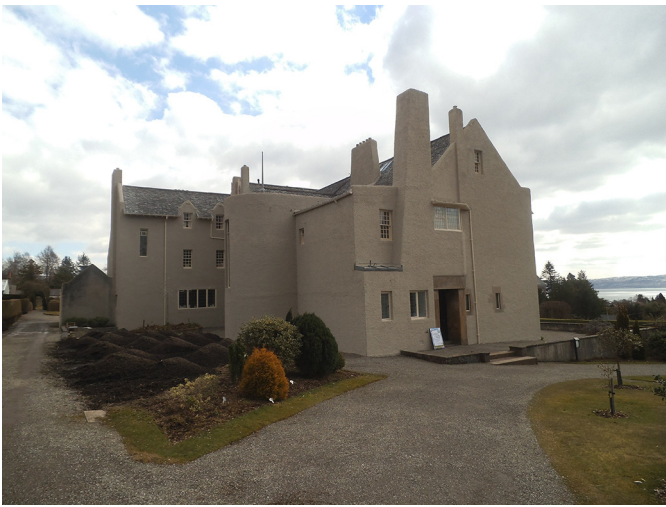
**Fig. 6.** The west façade and the entrance to the Hill House, Helensburgh, Argyll and Bute (C.R. Mackintosh, architect, 1904–5). This view was taken in 2013 some months after the exterior Portland Cement render had been painted to unify the appearance and improve resistance to environmental attack. The Clyde estuary can be seen in the background (Photograph: John Hughes).

The Hill House (Fig. 6) sits on an elevated, exposed, southwest-facing coastal site above the town of Helensburgh, approximately 30 km west of Glasgow. Designed and constructed during 1903–4 by the Glasgow-based architect Charles Rennie Mackintosh (1868–1928), it was commissioned by Scottish publisher Walter Blackie, as his family home. Mackintosh was a modern architect with a distinctive style variously associated with the Arts and Crafts, Art Nouveau and European secessionist movements. He is also known for design and furnishing of the interior of his buildings, in partnership with his wife Margaret Macdonald, as was the case at Hill House. Mackintosh’s status has increased significantly in recent decades, meaning that his surviving work now attracts the highest levels of statutory protection. The Hill House was designated a Category A Listed Building in 1971 and donated to the National Trust for Scotland (NTS) in 1982. It has a resident property manager, and is open to the public between April and October.

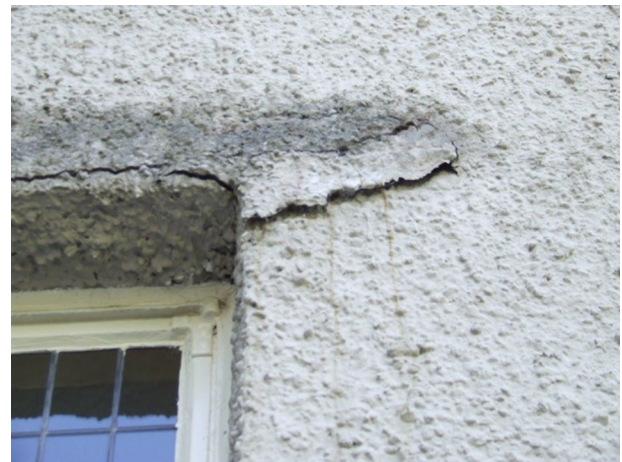
**Fig. 7.** Example of the cracking in the Portland Cement render of the Hill House, Helensburgh. Cracking such as this allows water ingress that threatens the historic Macintosh-Macdonald designed interior decoration and furniture (Photograph: John Hughes).

Mackintosh was keen to apply new materials in his buildings. Whilst the Hill House has solid masonry walls made from brick and soft red sandstone, the exterior is rendered in grey-coloured roughcast render, or “harl”, containing Portland Cement (PC). At the time, PC had gained currency and was promoted as the strongest, most waterproof material available [32]. This claim persuaded

Mackintosh to use it in his pursuit of novel, modern design values, allowing him to dispense with traditional water-shedding features, such as wall copes at gables and window cills. However, the inflexibility of the PC-based render, compared with a lime-based alternative, has resulted in extensive cracking (Fig. 7). PC’s low water permeability and high capillary retention traps any water ingress that occurs through the cracks causing further deterioration of the render, exacerbated by freeze-thaw action. In places, moisture has penetrated the whole wall, putting the Mackintosh-Macdonald interior at risk by increasing RH and condensation, resulting in mould growth. There have also been outbreaks of dry rot. Recent scientific investigations have focused on investigating the condition of the fabric of the building using materials analysis (petrographic thin sections and XRD) and thermography, alongside traditional engineering and condition surveying. The internal environment is being monitored with Hanwell recorders documenting temperature and RH in several rooms.

The NTS are in the process of examining the history of repairs and the scope of possible future interventions ([32]). Their deliberations centre on the status of the render, particularly the extent of original fabric remaining, and the technical repair challenges posed by previous interventions. In terms of conservation philosophy, there are questions regarding authenticity and whether this lies in the original fabric, or in the other aspects, such as the building’s design and Mackintosh’s intentions. During the 1980s, a hydrophobic silane was used with limited success, both as a surface water repellent coating and as a consolidant in conjunction with carbon rod ties in the interface between the PC harl and the degrading underlying sandstone ([32]: section 3.1). Current thinking questions the appropriateness of this former conservation strategy, since it used an irreversible experimental approach to preserve the fabric through introduction of a different manufactured material ([32]: 75). There are also concerns about whether the use of the silane consolidant has exacerbated problems with the harl, leading to further problems of water retention. Evidence now suggests that a considerable amount of the original render had in fact already been replaced during the Hill House’s life cycle, perhaps as much as 80%.
